**MUNICIPALITY OF KINCARDINE**

**BRIDGE OSIM REPORTS**

**2021**

**PEDESTRIAN STRUCTURES**

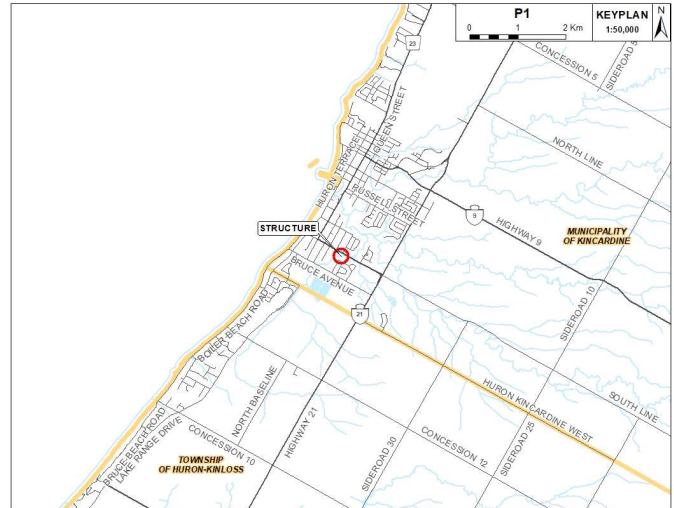
1-Facing South

<b>Structure Name:</b> Stonehaven Pedestrian Bridge	<b>BMROSS File #:</b> BR1083	<b>MTO #:</b>	
<b>Main Hwy / Road #:</b>	<b>Bridge Condition Index (BCI):</b> 97	<b>CRV:</b> \$400,400	
<b>Road Name:</b> Yellow Trail		<b>Inspection Date:</b> 7/21/2021	
<b>Structure Location:</b> South of Kincardine Ave		<b>Next Inspection:</b> 8/20/2023	
<b>Condition Summary:</b> Repairs recommended	<b>Recommended Timing:</b> 1-5 Years	<b>Current Load Limit:</b> N/A	
<b>Overall Comments:</b> Half-through truss in good condition. Vegetation should be cut back.

Overall Structure Notes:	
<b>Bridge Condition Summary:</b> Repairs recommended	<b>Recommended Timing:</b> 1-5 Years
<b>Overall Comments:</b> Half-through truss in good condition. Vegetation should be cut back.

Repair / Rehabilitation:			
Element:	Work Required	Period	Cost
Trusses/Arches	Cut back vegetation within 2.4m of bridge	1 to 5 yrs.	\$3,000
			\$0
			\$0
			\$0
			\$0
			\$0
			\$0
Various	Associated Work		\$0
		<b>Total</b>	\$3,000

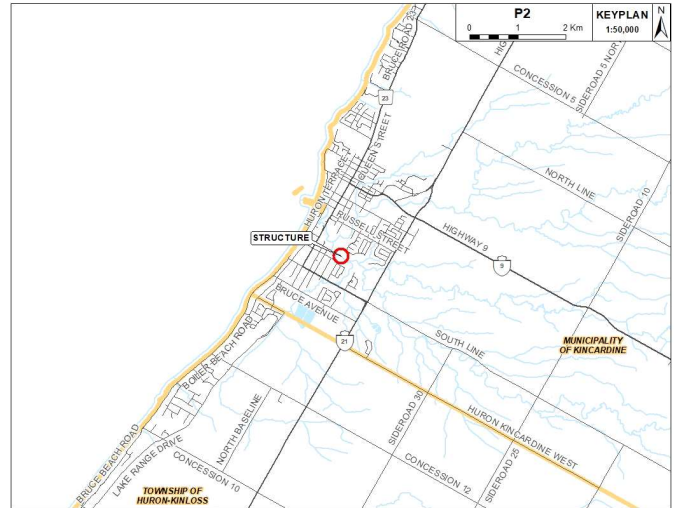
1-Facing South

Overall Structure Notes:	
<b>Bridge Condition Summary:</b> Repairs recommended	<b>Recommended Timing:</b> 1-5 Years
<b>Overall Comments:</b> Half-through truss in good condition. Plate over expansion locations recommended.

Repair / Rehabilitation:			
Element:	Work Required	Period	Cost
Decks	Cover plates for expansion locations	1 to 5 yrs.	\$2,000
			\$0
			\$0
			\$0
			\$0
			\$0
			\$0
Various	Associated Work		\$1,000
<b>Total</b>			<b>\$3,000</b>

Protection System:	None				BCI - Element Condition Values:	
Condition Data:	Excellent	Good	Fair	Poor	TEV	CEV
		100% (24.4)			\$10,248	\$7,686
Comments:	Dimensions vary.					
Performance Deficiencies:						
Recommended Work:						
					Recommended Timing:	None
Maintenance needs:						
Maintenance work:						
					Maintenance Priority:	
Element Data:						
Element Group:	Decks				Length:	75.05
Element Name:	Deck Top - Thin Slab				Width:	1.66
Location:					Height:	
Material:	Wood				Count:	1
Element Type:	Wood Planks				Total Quantity:	124.6 m2
Environment:	Benign				Limited / Not Inspected:	<input type="checkbox"/>
Protection System:	None				BCI - Element Condition Values:	
Condition Data:	Excellent	Good	Fair	Poor	TEV	CEV
		100% (124.6)			\$14,952	\$11,214
Comments:						
Performance Deficiencies:						
Recommended Work:	Cover plates to cover gaps between each span.					
					Recommended Timing:	1-5 years
Maintenance needs:

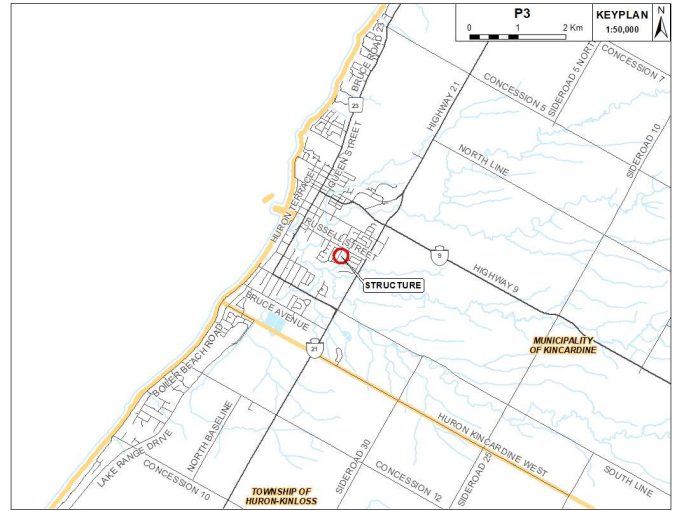
1-Facing East

Overall Structure Notes:	
<b>Bridge Condition Summary:</b> No work identified	<b>Recommended Timing:</b>
<b>Overall Comments:</b> Steel beam bridge with wood deck in good condition.

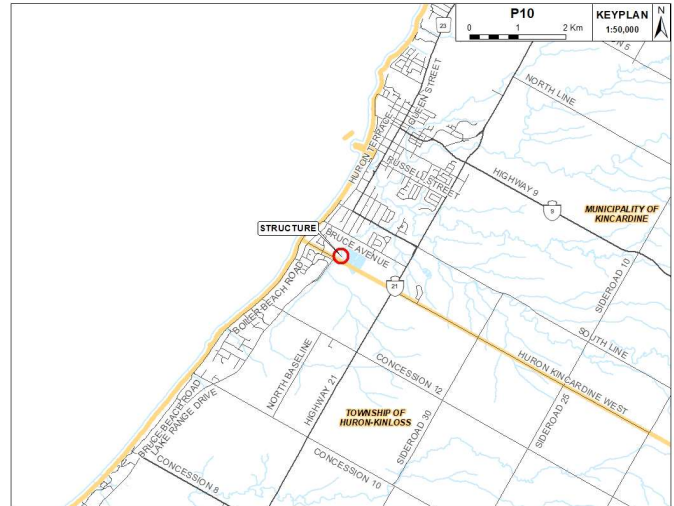
1-Facing East

Structure Name:	<input type="text"/>	BMROSS File #:	<input type="text"/>	MTO #:	<input type="text"/>
Main Hwy / Road #:	<input type="text"/>	Bridge Condition Index (BCI):	40	CRV:	\$223,600
Road Name:	Yellow Trail	Inspection Date:	7/21/2021		
Structure Location:	South of Bruce Ave.			Next Inspection:	8/20/2023
Condition Summary:	Repairs recommended	Recommended Timing:	1-5 Years		
Overall Comments:	Steel beam bridge with wood deck. Replace deteriorating deck boards.				
Current Load Limit:	N/A

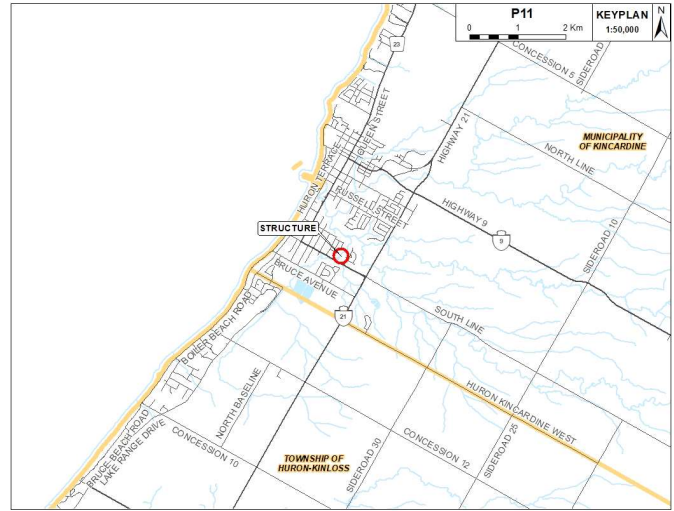
1-Facing North

<b>Structure Name:</b> <input type="text"/>	<b>BMROSS File #:</b> <input type="text"/>	<b>MTO #:</b> <input type="text"/>	
<b>Main Hwy / Road #:</b> <input type="text"/>	<b>Bridge Condition Index (BCI):</b> <input type="text" value="40"/>	<b>CRV:</b> <input type="text" value="\$62,400"/>	
<b>Road Name:</b> <input type="text" value="Green Trail"/>		<b>Inspection Date:</b> <input type="text" value="7/21/2021"/>	
<b>Structure Location:</b> <input type="text" value="North of Kincardine Ave."/>		<b>Next Inspection:</b> <input type="text" value="8/20/2023"/>	
<b>Condition Summary:</b> <input type="text" value="Repairs recommended"/>	<b>Recommended Timing:</b> <input type="text" value="1-5 Years"/>	<b>Current Load Limit:</b> <input type="text" value="N/A"/>	
<b>Overall Comments:</b> <input type="text" value="Wood bridge in fair condition. Railing reinforcement recommended."/>

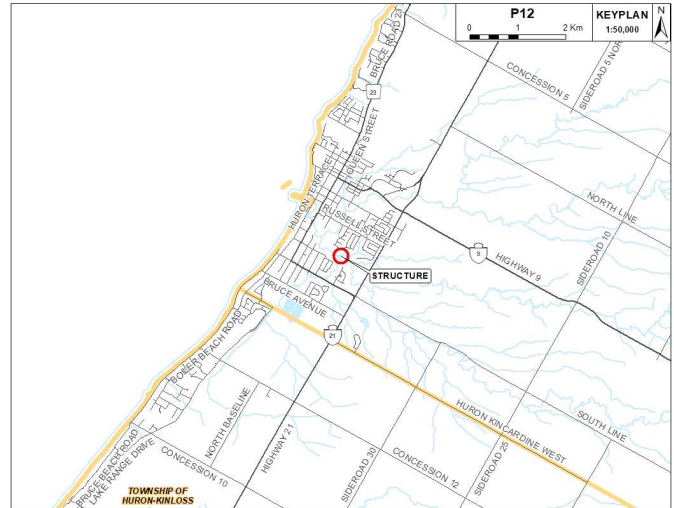
1-Facing South

<b>Structure Name:</b> <input type="text"/>	<b>BMROSS File #:</b> <input type="text"/>	<b>MTO #:</b> <input type="text"/>
<b>Main Hwy / Road #:</b> <input type="text"/>	<b>Bridge Condition Index (BCI):</b> <input type="text" value="4"/>	<b>CRV:</b> <input type="text" value="\$52,000"/>
<b>Road Name:</b> <input type="text" value="Green Trail"/>	<b>Inspection Date:</b> <input type="text" value="7/21/2021"/>	
<b>Structure Location:</b> <input type="text"/>	<b>Next Inspection:</b> <input type="text" value="8/20/2023"/>	
<b>Condition Summary:</b> <input type="text" value="Repairs recommended"/> <b>Recommended Timing:</b> <input type="text" value="1-5 Years"/>	<b>Current Load Limit:</b> <input type="text" value="N/A"/>	
<b>Overall Comments:</b> <input type="text" value="Log beam bridge supporting wood decking. Bridge is in poor condition."/>

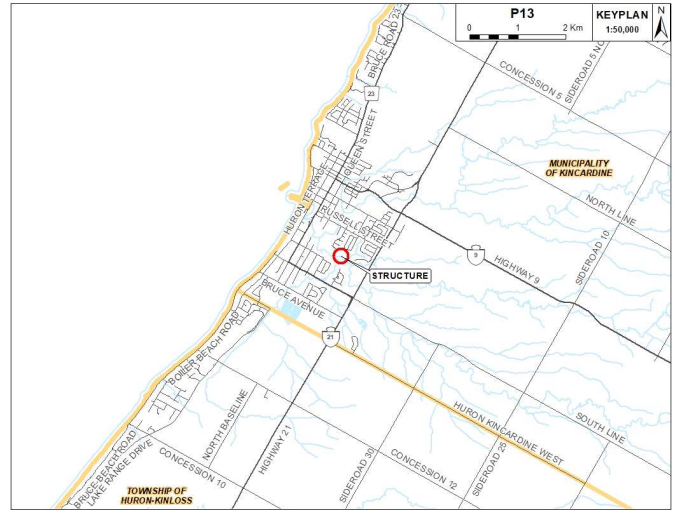
1-Facing South

<b>Structure Name:</b> <input type="text"/>	<b>BMROSS File #:</b> <input type="text"/>	<b>MTO #:</b> <input type="text"/>
<b>Main Hwy / Road #:</b> <input type="text"/>	<b>Bridge Condition Index (BCI):</b> <input type="text" value="75"/>	<b>CRV:</b> <input type="text" value="\$176,800"/>
<b>Road Name:</b> <input type="text" value="Green Trail"/>	<b>Inspection Date:</b> <input type="text" value="7/21/2021"/>	
<b>Structure Location:</b> <input type="text" value="Transition from Green to Red Trail"/>	<b>Next Inspection:</b> <input type="text" value="8/20/2023"/>	
<b>Condition Summary:</b> <input type="text" value="No work identified"/>	<b>Recommended Timing:</b> <input type="text"/>	<b>Current Load Limit:</b> <input type="text" value="N/A"/>
<b>Overall Comments:</b> <input type="text" value="Aluminum seasonal bridge - installed in the spring and removed in the fall. Bridge is in good condition. Support condition should be monitored."/>
