**MUNICIPALITY OF KINCARDINE**

**BRIDGE OSIM REPORTS**

**2021**

**PEDESTRIAN STRUCTURES**

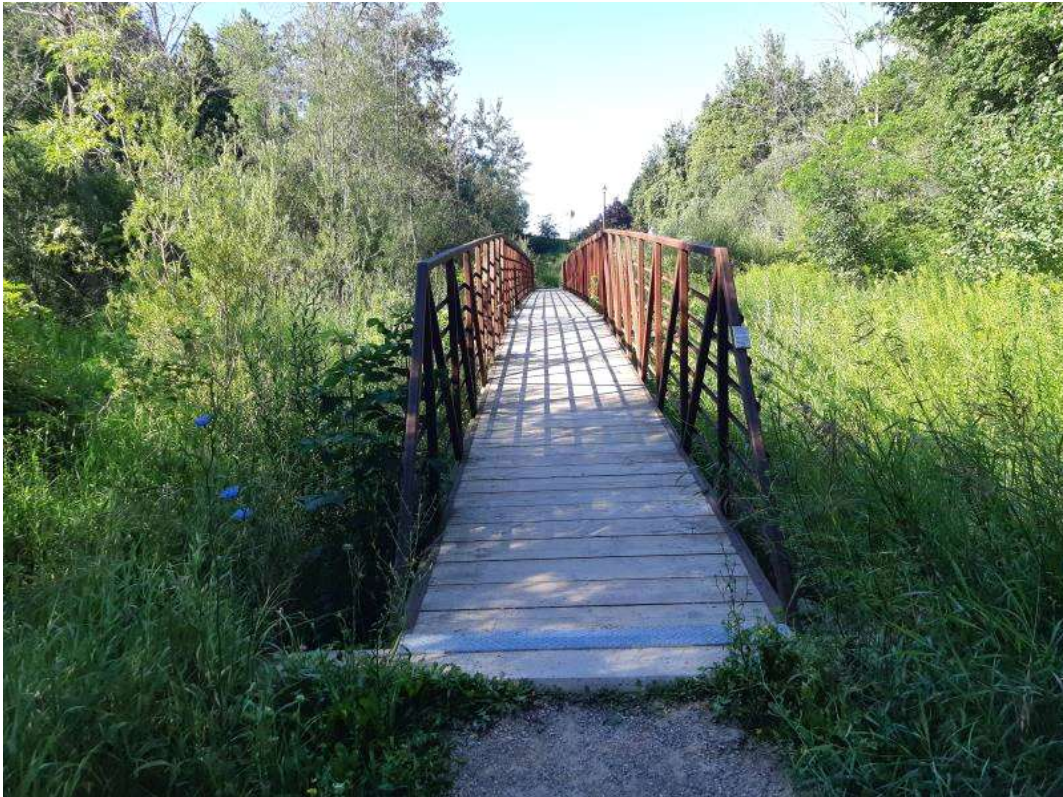
1-Facing South

Overall Structure Notes:	
<b>Bridge Condition Summary:</b> Repairs recommended	<b>Recommended Timing:</b> 1-5 Years
<b>Overall Comments:</b> Half-through truss in good condition. Vegetation should be cut back.

Repair / Rehabilitation:			
Element:	Work Required	Period	Cost
Trusses/Arches	Cut back vegetation within 2.4m of bridge	1 to 5 yrs.	\$3,000
			\$0
			\$0
			\$0
			\$0
			\$0
			\$0
Various	Associated Work		\$0
		<b>Total</b>	\$3,000

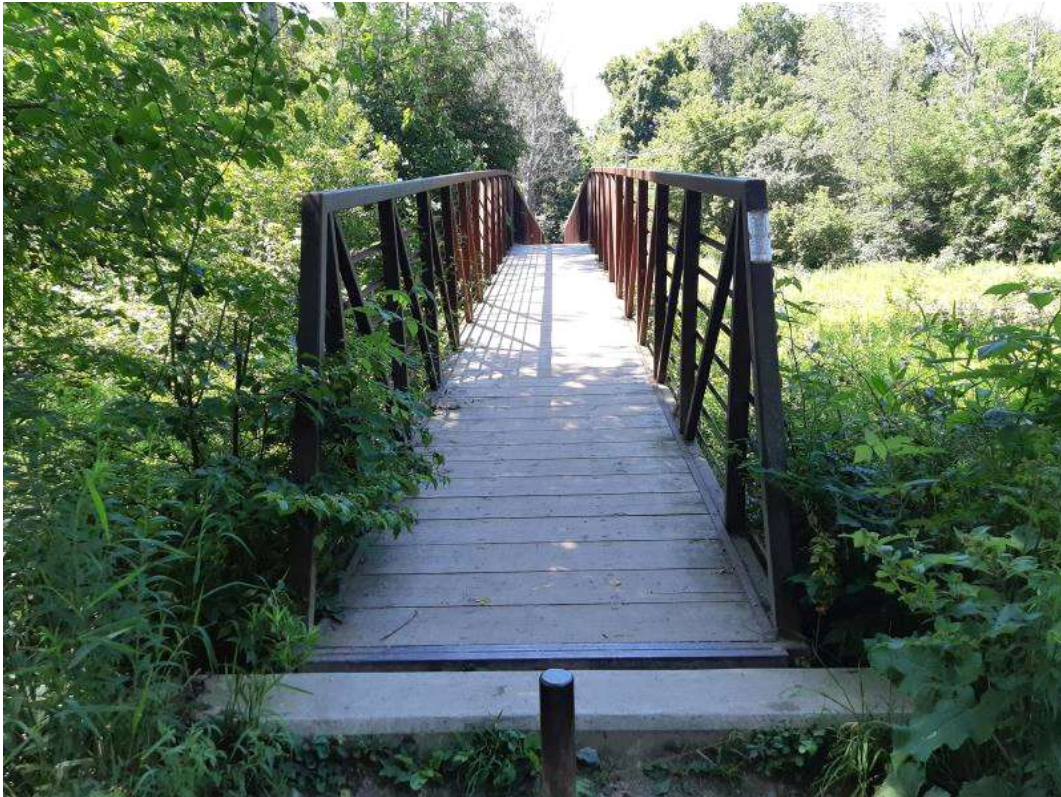
1-Facing South

Overall Structure Notes:	
<b>Bridge Condition Summary:</b> Repairs recommended	<b>Recommended Timing:</b> 1-5 Years
<b>Overall Comments:</b> Half-through truss in good condition. Plate over expansion locations recommended.

Repair / Rehabilitation:			
Element:	Work Required	Period	Cost
Decks	Cover plates for expansion locations	1 to 5 yrs.	\$2,000
			\$0
			\$0
			\$0
			\$0
			\$0
			\$0
<b>Repair/Rehabilitation Sub-Total:</b>			<b>\$2,000</b>

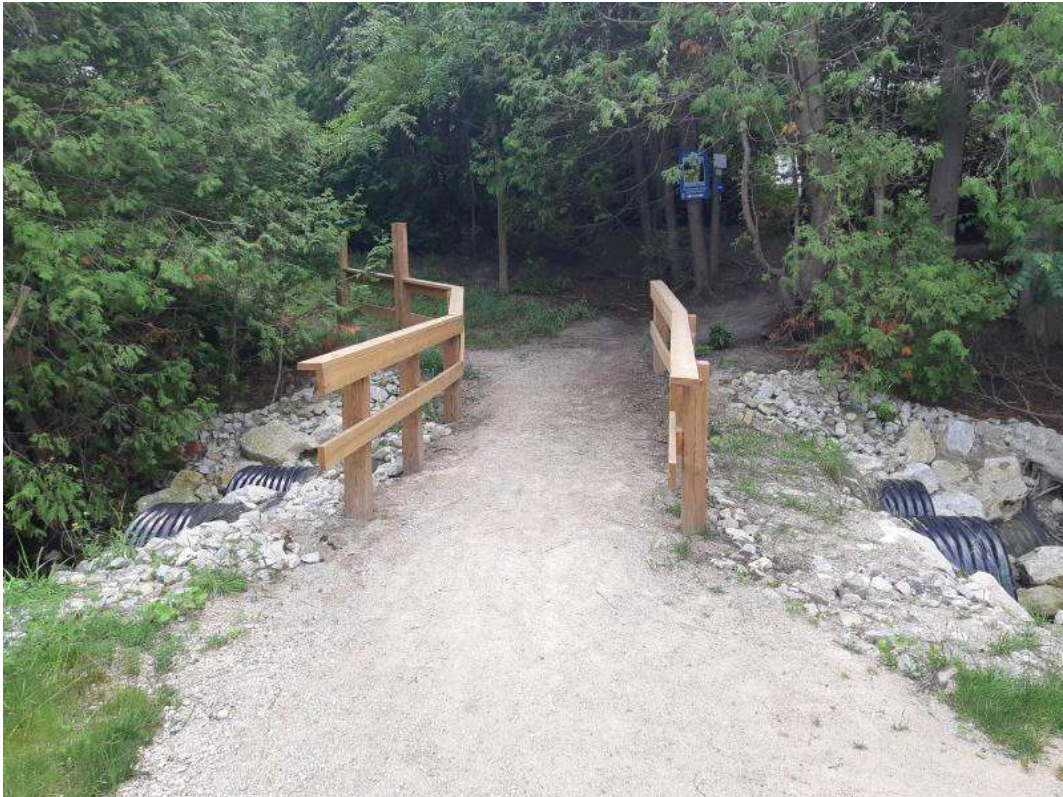
1-Facing South

Structure Name: <input type="text"/>	BMROSS File #: <input type="text"/>	MTO #: <input type="text"/>
Main Hwy / Road #: <input type="text"/>	Bridge Condition Index (BCI): <input type="text" value="100"/>	CRV: <input type="text" value="\$62,400"/>
Road Name: <input type="text" value="Blue Trail"/>	Inspection Date: <input type="text" value="7/22/2021"/>	
Structure Location: <input type="text" value="Alps Park"/>	Next Inspection: <input type="text" value="8/20/2023"/>	
Condition Summary: <input type="text" value="No work identified"/>	Recommended Timing: <input type="text"/>	Current Load Limit: <input type="text" value="N/A"/>
Overall Comments: <input type="text" value="Twin CSP in excellent condition."/>

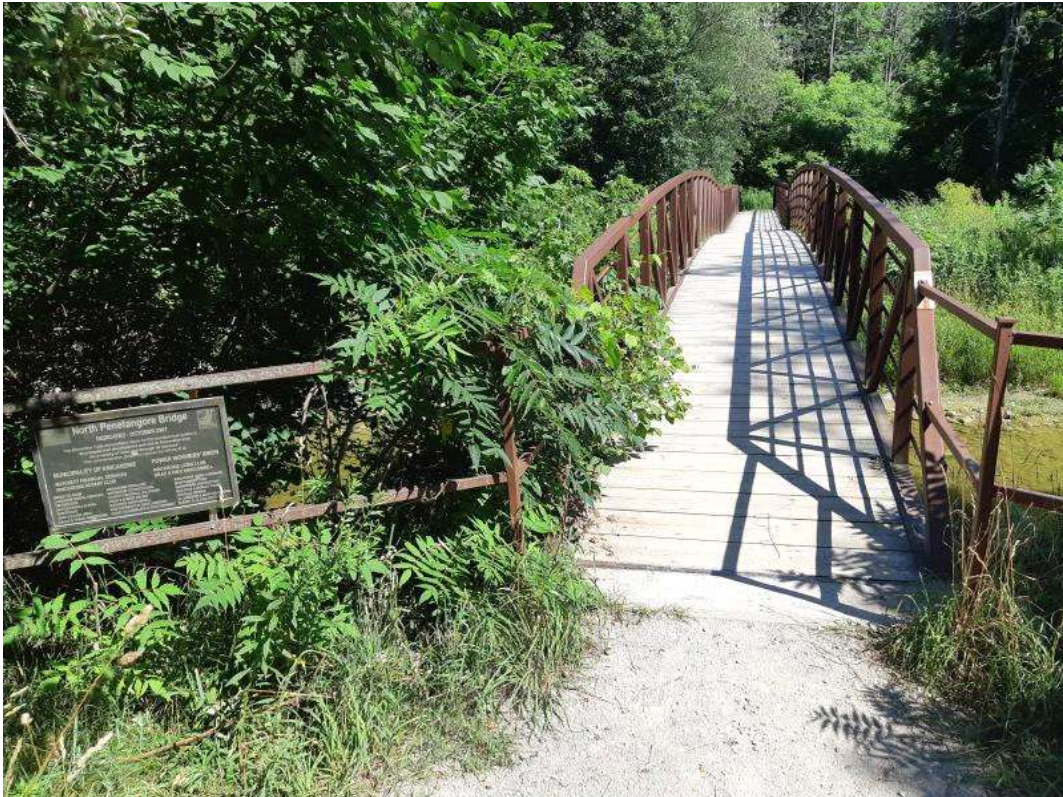
1-Facing East

<b>Structure Name:</b> <input type="text" value="North Penetangore Bridge"/>	<b>BMROSS File #:</b> <input type="text" value="BR804"/>	<b>MTO #:</b> <input type="text"/>
<b>Main Hwy / Road #:</b> <input type="text"/>	<b>Bridge Condition Index (BCI):</b> <input type="text" value="78"/>	<b>CRV:</b> <input type="text" value="\$348,400"/>
<b>Road Name:</b> <input type="text" value="Red Trail"/>	<b>Inspection Date:</b> <input type="text" value="7/21/2021"/>	
<b>Structure Location:</b> <input type="text" value="Geddes Park"/>	<b>Next Inspection:</b> <input type="text" value="8/20/2023"/>	
<b>Condition Summary:</b> <input type="text" value="No work identified"/>	<b>Recommended Timing:</b> <input type="text"/>	<b>Current Load Limit:</b> <input type="text" value="N/A"/>
<b>Overall Comments:</b> <input type="text" value="Half-through truss in good condition."/>

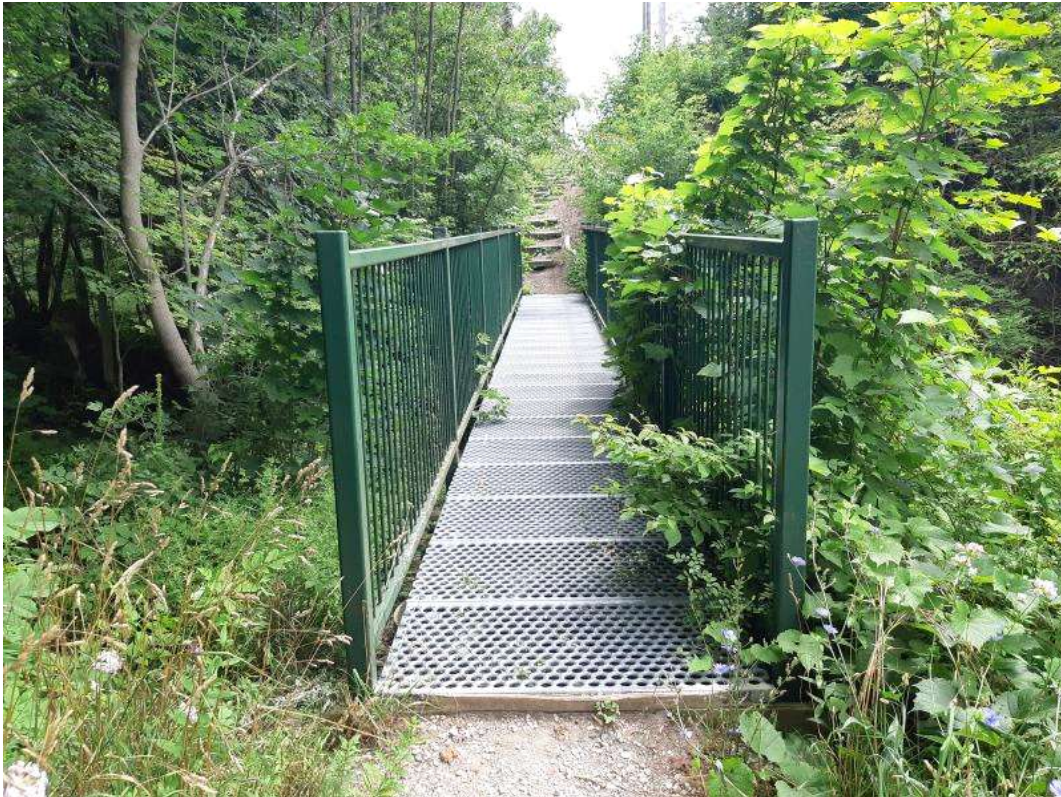
1-Facing East

Structure Name: <input type="text"/>	BMROSS File #: <input type="text"/>	MTO #: <input type="text"/>
Main Hwy / Road #: <input type="text"/>	Bridge Condition Index (BCI): <input type="text" value="75"/>	CRV: <input type="text" value="\$98,800"/>
Road Name: <input type="text" value="Blue Trail"/>		Inspection Date: <input type="text" value="7/22/2021"/>
Structure Location: <input type="text" value="Mechanics Avenue"/>		Next Inspection: <input type="text" value="8/20/2023"/>
Condition Summary: <input type="text" value="Repairs recommended"/>	Recommended Timing: <input type="text" value="1-5 Years"/>	Current Load Limit: <input type="text" value="N/A"/>
Overall Comments: <input type="text" value="Steel beam bridge with steel grating in good condition."/>

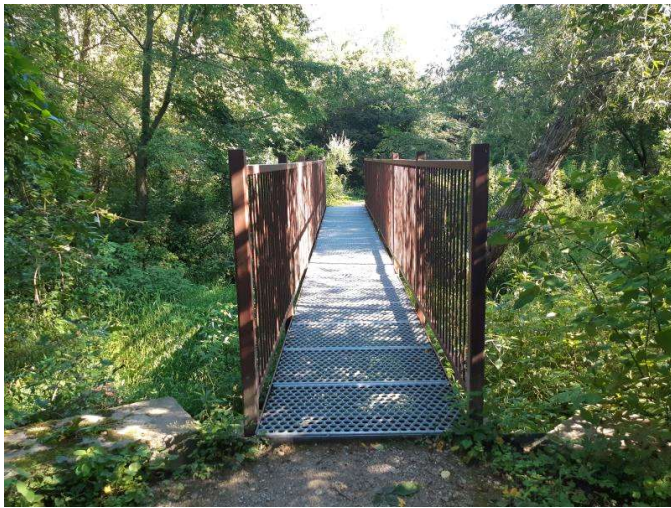
1-Facing North

<b>Structure Name:</b> <input type="text"/>	<b>BMROSS File #:</b> <input type="text"/>	<b>MTO #:</b> <input type="text"/>	
<b>Main Hwy / Road #:</b> <input type="text"/>	<b>Bridge Condition Index (BCI):</b> <input type="text" value="75"/>	<b>CRV:</b> <input type="text" value="\$83,200"/>	
<b>Road Name:</b> <input type="text" value="Yellow Trail"/>		<b>Inspection Date:</b> <input type="text" value="7/21/2021"/>	
<b>Structure Location:</b> <input type="text" value="Between Bruce Ave. and Kincardine Ave."/>		<b>Next Inspection:</b> <input type="text" value="8/20/2023"/>	
<b>Condition Summary:</b> <input type="text" value="No work identified"/>	<b>Recommended Timing:</b> <input type="text"/>	<b>Current Load Limit:</b> <input type="text" value="N/A"/>	
<b>Overall Comments:</b> <input type="text" value="Steel beam bridge with steel grating deck in good condition."/>

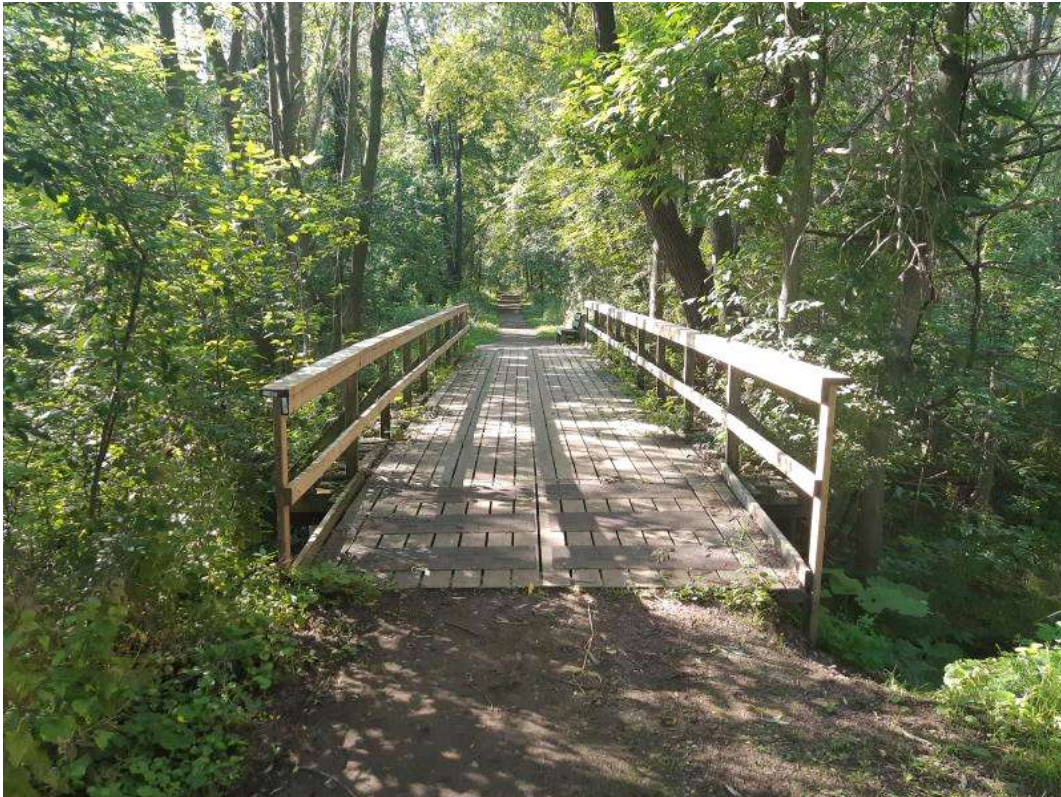
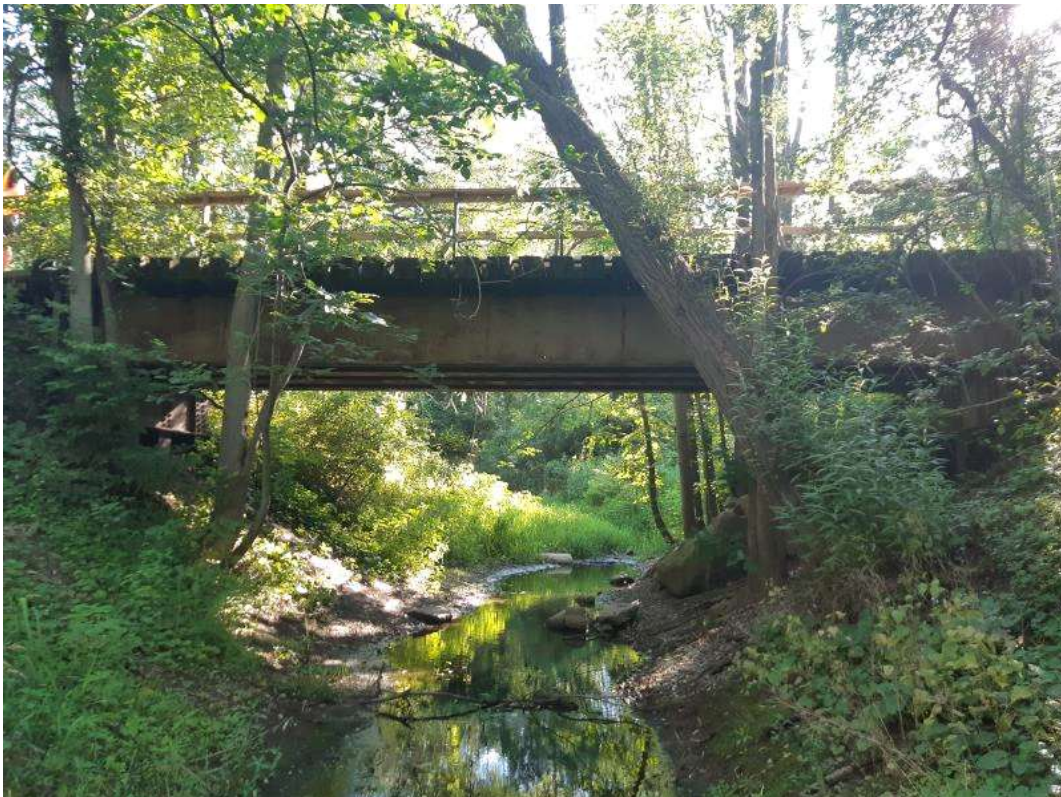
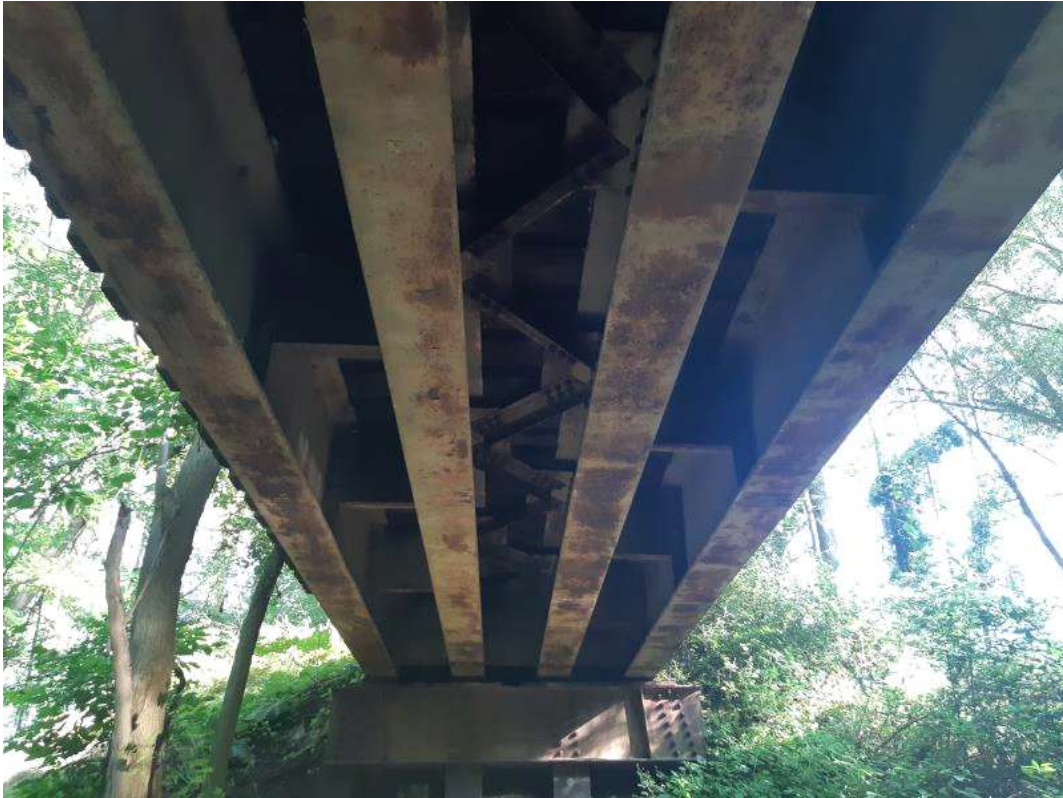
Overall Structure Notes:	
<b>Bridge Condition Summary:</b> Repairs recommended	<b>Recommended Timing:</b> 1-5 Years
<b>Overall Comments:</b> Steel beam bridge with wood deck. Replace deteriorating deck boards.

Protection System:	None			BCI - Element Condition Values:		
Condition Data:	Excellent	Good	Fair	Poor	TEV	CEV
			70% (2.73)	30% (1.17)	\$390	\$109
Comments:	Cross member and handrails replaced recently. Some posts loose and rotting.					
Performance Deficiencies:						
Recommended Work:	Repair and improve railings.					
					Recommended Timing:	1-5 years
Maintenance needs:						
Maintenance work:					Maintenance Priority:	
Element Data:						
Element Group:	Beams/ML'E's			Length:	2.2	
Element Name:	Diaphragms			Width:		
Location:	End span			Height:	0.61	
Material:	Steel			Count:	2	
Element Type:	Cross Type			Total Quantity:	2 Each	
Environment:	Benign			Limited / Not Inspected:	<input type="checkbox"/>	
Protection System:	None			BCI - Element Condition Values:		
Condition Data:	Excellent	Good	Fair	Poor	TEV	CEV
			100% (2)		\$0	\$0
Comments:						
Performance Deficiencies:						
Recommended Work:						
					Recommended Timing:	None

Repair / Rehabilitation:			
Element:	Work Required	Period	Cost
Decks	Replace deteriorated deck boards	1 to 5 yrs.	\$3,000
Barriers	Improve railings	1 to 5 yrs.	\$2,000
			\$0
			\$0
			\$0
			\$0
			\$0
Various	Associated Work		\$0
		<b>Total</b>	<b>\$5,000</b>

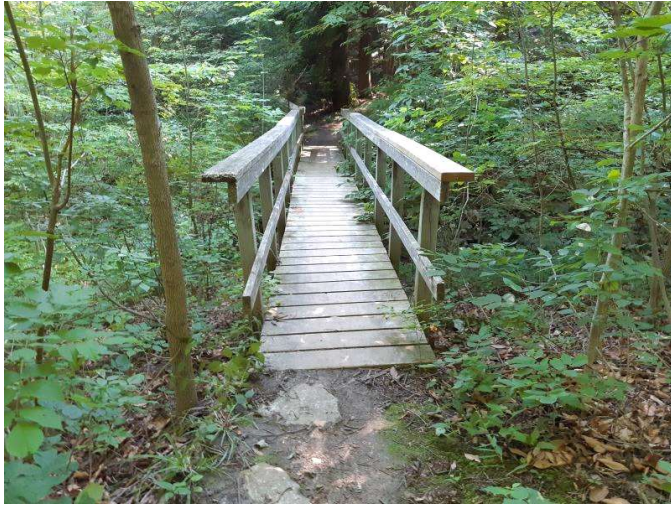
1-Facing North

<b>Structure Name:</b> <input type="text"/>	<b>BMROSS File #:</b> <input type="text"/>	<b>MTO #:</b> <input type="text"/>	
<b>Main Hwy / Road #:</b> <input type="text"/>	<b>Bridge Condition Index (BCI):</b> <input type="text" value="40"/>	<b>CRV:</b> <input type="text" value="\$62,400"/>	
<b>Road Name:</b> <input type="text" value="Green Trail"/>		<b>Inspection Date:</b> <input type="text" value="7/21/2021"/>	
<b>Structure Location:</b> <input type="text" value="North of Kincardine Ave."/>		<b>Next Inspection:</b> <input type="text" value="8/20/2023"/>	
<b>Condition Summary:</b> <input type="text" value="Repairs recommended"/>	<b>Recommended Timing:</b> <input type="text" value="1-5 Years"/>	<b>Current Load Limit:</b> <input type="text" value="N/A"/>	
<b>Overall Comments:</b> <input type="text" value="Wood bridge in fair condition. Railing reinforcement recommended."/>

Repair / Rehabilitation:			
Element:	Work Required	Period	Cost
Barriers	Reinforce railings and adjust pier supports	1 to 5 yrs.	\$5,000
			\$0
			\$0
			\$0
			\$0
			\$0
			\$0
Various	Associated Work		\$0
		<b>Total</b>	<b>\$5,000</b>

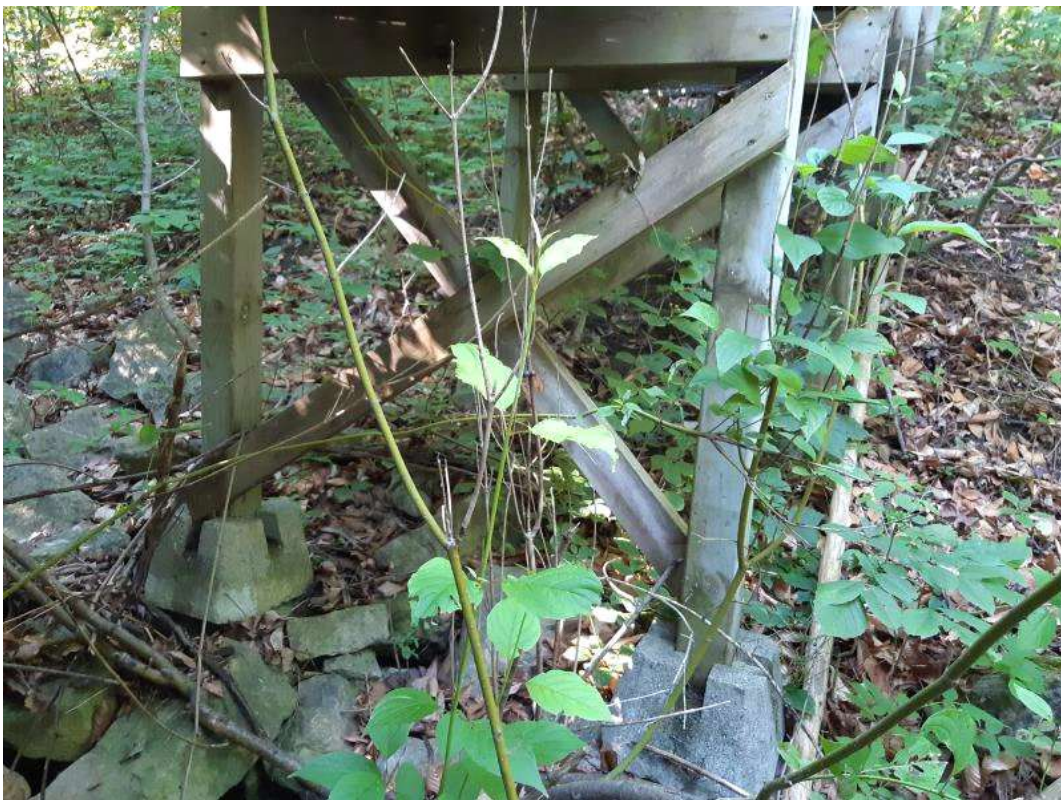
4-Pier

Element Data:						
<b>Element Group:</b>	Piers			<b>Length:</b>	2.2	
<b>Element Name:</b>	Shafts/Columns/Pile Bents			<b>Width:</b>	0.09	
<b>Location:</b>				<b>Height:</b>	0.09	
<b>Material:</b>	Wood			<b>Count:</b>	18	
<b>Element Type:</b>				<b>Total Quantity:</b>	18 Each	
<b>Environment:</b>	Benign			<b>Limited / Not Inspected:</b>	<input type="checkbox"/>	
<b>Protection System:</b>	None			<b>BCI - Element Condition Values:</b>		
<b>Condition Data:</b>	<b>Excellent</b>	<b>Good</b>	<b>Fair</b>	<b>Poor</b>	<b>TEV</b>	<b>CEV</b>
			100% (18)		\$16,200	\$6,480
<b>Comments:</b>	4x4 wood posts resting on concrete base posts. Extend past deck to support railing.					
<b>Performance Deficiencies:</b>						
<b>Recommended Work:</b>	Monitor support conditions.				<b>Recommended Timing:</b>	1-5 years
<b>Maintenance needs:</b>						
<b>Maintenance work:</b>					<b>Maintenance Priority:</b>

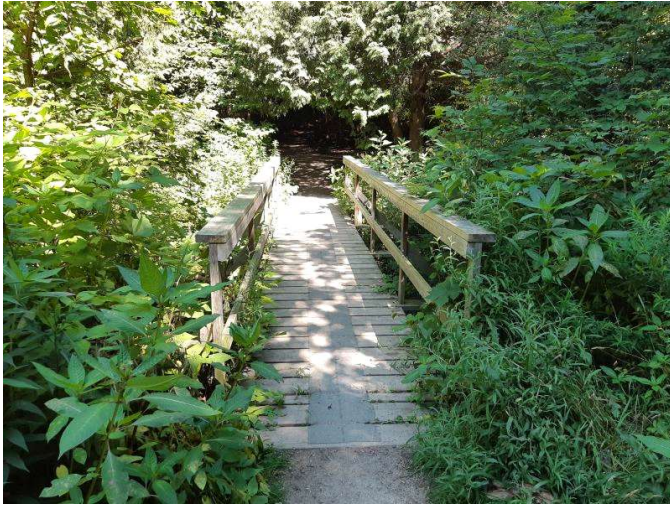
1-Facing West

<b>Structure Name:</b> <input type="text"/>	<b>BMROSS File #:</b> <input type="text"/>	<b>MTO #:</b> <input type="text"/>
<b>Main Hwy / Road #:</b> <input type="text"/>	<b>Bridge Condition Index (BCI):</b> <input type="text" value="62"/>	<b>CRV:</b> <input type="text" value="\$78,000"/>
<b>Road Name:</b> <input type="text" value="Red Trail"/>	<b>Inspection Date:</b> <input type="text" value="7/21/2021"/>	
<b>Structure Location:</b> <input type="text"/>	<b>Next Inspection:</b> <input type="text" value="8/20/2023"/>	
<b>Condition Summary:</b> <input type="text" value="No work identified"/>	<b>Recommended Timing:</b> <input type="text"/>	<b>Current Load Limit:</b> <input type="text" value="N/A"/>
<b>Overall Comments:</b> <input type="text" value="Aluminum girders supporting wood decking. Bridge is in fair to good condition."/>

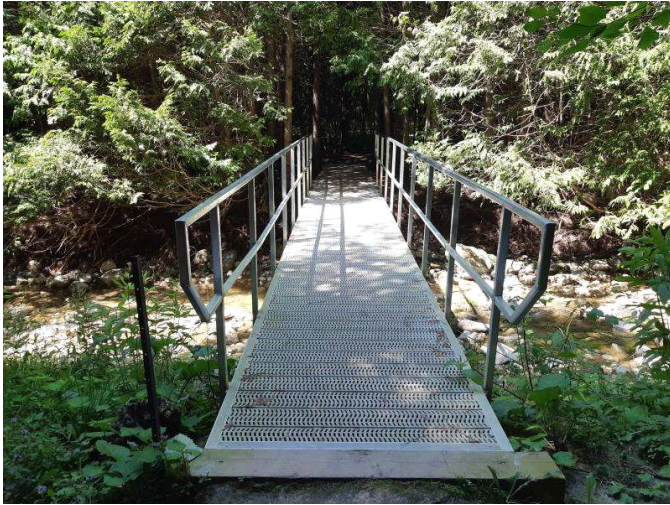
1-Facing North

<b>Structure Name:</b> <input type="text"/>	<b>BMROSS File #:</b> <input type="text"/>	<b>MTO #:</b> <input type="text"/>	
<b>Main Hwy / Road #:</b> <input type="text"/>	<b>Bridge Condition Index (BCI):</b> <input type="text" value="75"/>	<b>CRV:</b> <input type="text" value="\$67,600"/>	
<b>Road Name:</b> <input type="text" value="Red Trail"/>		<b>Inspection Date:</b> <input type="text" value="7/21/2021"/>	
<b>Structure Location:</b> <input type="text"/>		<b>Next Inspection:</b> <input type="text" value="8/20/2023"/>	
<b>Condition Summary:</b> <input type="text" value="No work identified"/>	<b>Recommended Timing:</b> <input type="text"/>	<b>Current Load Limit:</b> <input type="text" value="N/A"/>	
<b>Overall Comments:</b> <input type="text" value="Aluminum seasonal bridge - installed in the spring and removed in the fall. Bridge is in good condition. Support condition should be monitored."/>

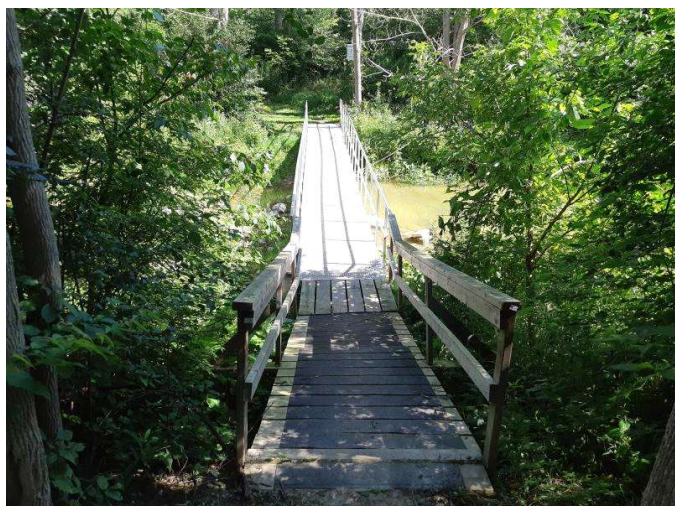
1-Facing North

<b>Structure Name:</b> <input type="text"/>	<b>BMROSS File #:</b> <input type="text"/>	<b>MTO #:</b> <input type="text"/>
<b>Main Hwy / Road #:</b> <input type="text"/>	<b>Bridge Condition Index (BCI):</b> <input type="text" value="75"/>	<b>CRV:</b> <input type="text" value="\$109,200"/>
<b>Road Name:</b> <input type="text" value="Red Trail"/>	<b>Inspection Date:</b> <input type="text" value="7/21/2021"/>	
<b>Structure Location:</b> <input type="text" value="South End of Red Trail"/>	<b>Next Inspection:</b> <input type="text" value="8/20/2023"/>	
<b>Condition Summary:</b> <input type="text" value="No work identified"/>	<b>Recommended Timing:</b> <input type="text"/>	<b>Current Load Limit:</b> <input type="text" value="N/A"/>
<b>Overall Comments:</b> <input type="text" value="Aluminum seasonal bridge - installed in the spring and removed in the fall. Bridge is in good condition. Support condition should be monitored."/>

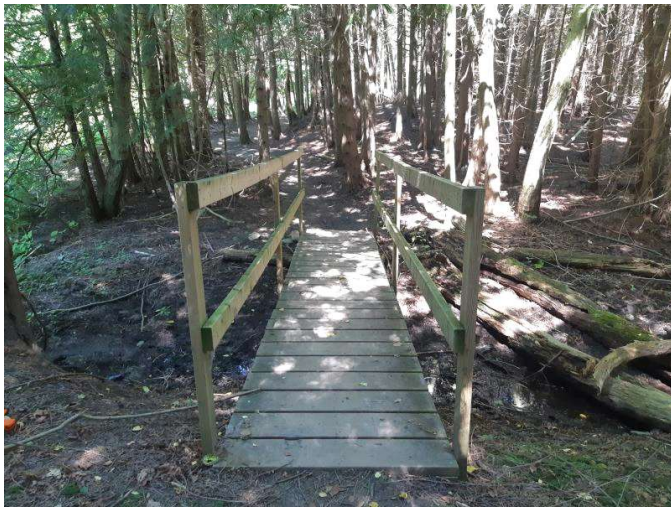
1-Facing East

Structure Name:	<input type="text"/>	BMROSS File #:	<input type="text"/>	MTO #:	<input type="text"/>	
Main Hwy / Road #:	<input type="text"/>	Bridge Condition Index (BCI):	40	CRV:	\$26,000	
Road Name:	Red Trail	Inspection Date:	7/21/2021			
Structure Location:	East End of Red Trail		Next Inspection:	8/20/2023		
Condition Summary:	No work identified	Recommended Timing:	<input type="text"/>		Current Load Limit:	N/A
Overall Comments:	Wood structure in fair condition.

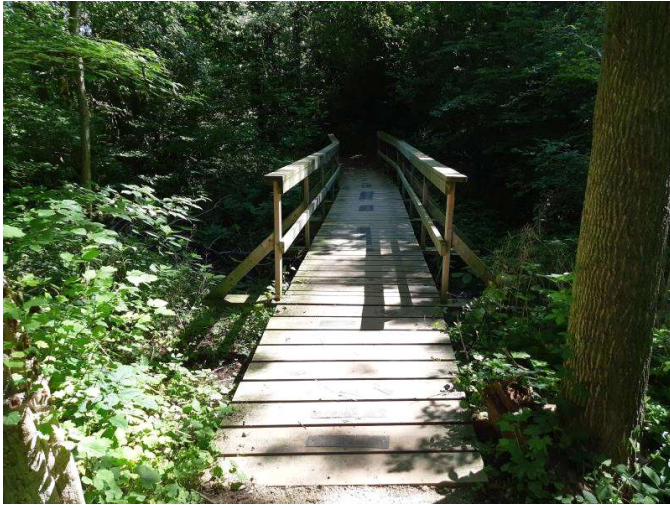
1-Facing North

Structure Name: <input type="text"/>	BMROSS File #: <input type="text"/>	MTO #: <input type="text"/>
Main Hwy / Road #: <input type="text"/>	Bridge Condition Index (BCI): <input type="text" value="50"/>	CRV: <input type="text" value="\$93,600"/>
Road Name: <input type="text" value="Red Trail"/>	Inspection Date: <input type="text" value="7/21/2021"/>	
Structure Location: <input type="text" value="North End of Red Trail"/>	Next Inspection: <input type="text" value="8/20/2023"/>	
Condition Summary: <input type="text" value="No work identified"/>	Recommended Timing: <input type="text"/>	Current Load Limit: <input type="text" value="N/A"/>
Overall Comments: <input type="text" value="Aluminum beams supporting wood decking in fair condition."/>

Protection System:	None			BCI - Element Condition Values:		
Condition Data:	Excellent	Good	Fair	Poor	TEV	CEV
			100% (24.6)		\$2,460	\$984
Comments:	Railings don't meet code for opening size, height, or resistance.					
Performance Deficiencies:						
Recommended Work:						
					Recommended Timing:	
Maintenance needs:						
Maintenance work:					Maintenance Priority:	
Element Data:						
Element Group:	Beams/MLE's			Length:	7.1	
Element Name:	Girders			Width:	0.085	
Location:				Height:	0.33	
Material:	Aluminium			Count:	2	
Element Type:	I-type			Total Quantity:	13 m2	
Environment:	Benign			Limited / Not Inspected:	<input type="checkbox"/>	
Protection System:	None			BCI - Element Condition Values:		
Condition Data:	Excellent	Good	Fair	Poor	TEV	CEV
			100% (13)		\$2,600	\$1,040
Comments:	Additional height at midspan. Noticeable deflection when walking.					
Performance Deficiencies:						
Recommended Work:

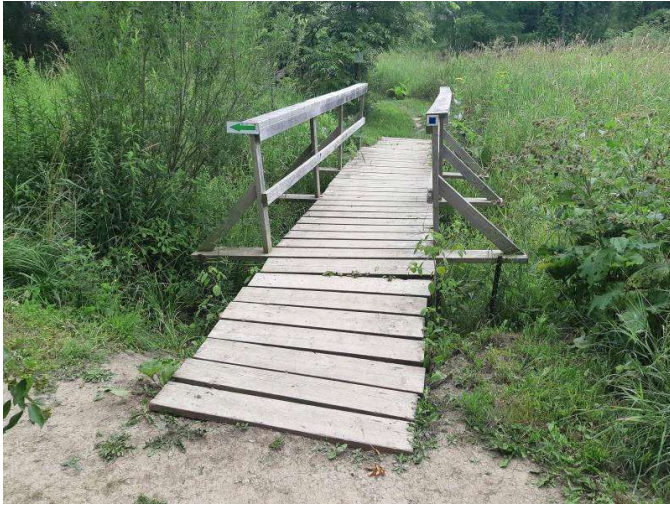
1-Facing East

Structure Name:	<input type="text"/>	BMROSS File #:	<input type="text"/>	MTO #:	<input type="text"/>	
Main Hwy / Road #:	<input type="text"/>	Bridge Condition Index (BCI):	58	CRV:	\$36,400	
Road Name:	Blue Trail	Inspection Date:	7/22/2021			
Structure Location:	89-North Line Extension		Next Inspection:	8/20/2023		
Condition Summary:	Repairs recommended	Recommended Timing:	1-5 Years		Current Load Limit:	N/A
Overall Comments:	Aluminum beams supporting wood deck. Bridge is in fair condition but supports should continue to be monitored.

Condition Data:	Excellent	Good	Fair	Poor	TEV	CEV
			100% (2)		\$120	\$48
Comments:	Out of alignment with deck.					
Performance Deficiencies:						
Recommended Work:	Re-align approaches.				Recommended Timing:	1-5 years
Maintenance needs:						
Maintenance work:					Maintenance Priority:	
Element Data:						
Element Group:	Barriers			Length:	4.9	
Element Name:	Railing Systems			Width:	0.038	
Location:				Height:	0.96	
Material:	Wood			Count:	2	
Element Type:	Wood Rail >83mm thick on Wood Post			Total Quantity:	9.8 m2	
Environment:	Benign			Limited / Not Inspected:	<input type="checkbox"/>	
Protection System:	None			BCI - Element Condition Values:		
Condition Data:	Excellent	Good	Fair	Poor	TEV	CEV
			100% (9.8)		\$980	\$392
Comments:	Railings don't meet code for height, resistance, or opening size.					
Performance Deficiencies:						
Recommended Work:	Reinforce railings.				Recommended Timing:	1-5 years
Maintenance needs:

Repair / Rehabilitation:				
Element:	Work Required	Period	Cost	
Approaches	Re-align approaches	1 to 5 yrs.	\$6,000	
Barriers	Reinforce railings	1 to 5 yrs.	\$4,000	
			\$0	
			\$0	
			\$0	
			\$0	
			\$0	
Various	Associated Work		\$0	
		<b>Total</b>	<b>\$10,000</b>

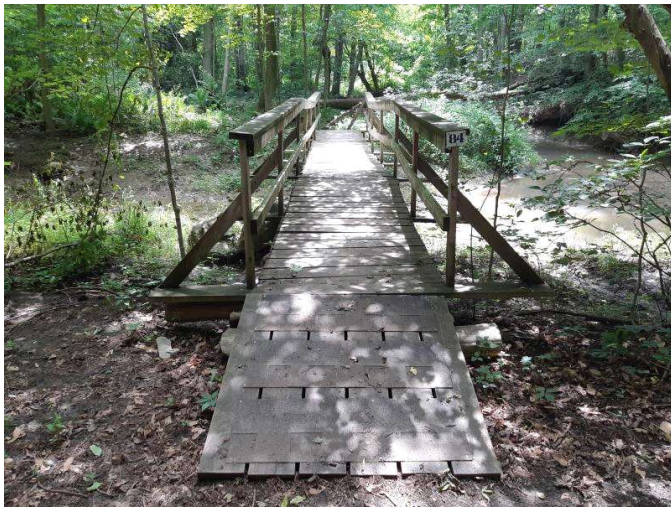
1-Facing South

Structure Name:	<input type="text"/>	BMROSS File #:	<input type="text"/>	MTO #:	<input type="text"/>	
Main Hwy / Road #:	<input type="text"/>	Bridge Condition Index (BCI):	33	CRV:	\$78,000	
Road Name:	Blue Trail	Inspection Date:	7/22/2021			
Structure Location:	84-North Line Extension		Next Inspection:	8/20/2023		
Condition Summary:	Repairs recommended	Recommended Timing:	1-5 Years		Current Load Limit:	N/A
Overall Comments:	Log beam bridge supporting wood deck. Reinforcement recommended.

Condition Data:	Excellent	Good	Fair	Poor	TEV	CEV
			100% (4.25)		\$3,825	\$1,530
Comments:	Pier is a timber crib filled with stones.					
Performance Deficiencies:						
Recommended Work:	Reinforce bridge.				Recommended Timing:	1-5 years
					Maintenance Priority:	
Maintenance needs:						
Maintenance work:

Repair / Rehabilitation:			
Element:	Work Required	Period	Cost
Beams/MLE's	Reinforcement recommended	1 to 5 yrs.	\$15,000
			\$0
			\$0
			\$0
			\$0
			\$0
			\$0
Various	Associated Work		\$0
		<b>Total</b>	<b>\$15,000</b>

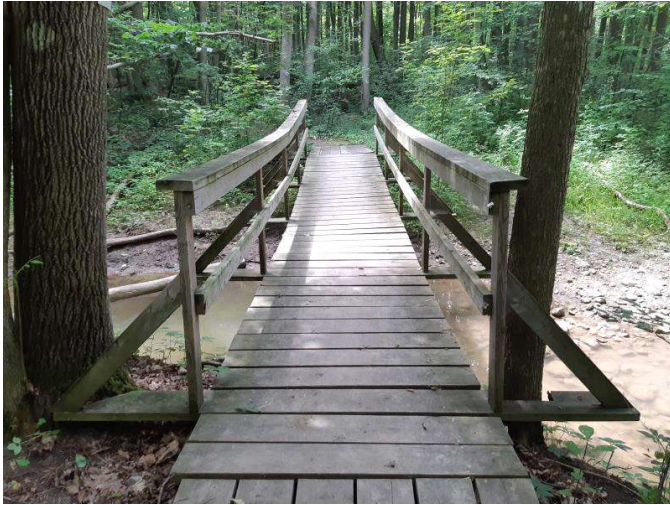
1-Facing South

<b>Structure Name:</b> <input type="text"/>	<b>BMROSS File #:</b> <input type="text"/>	<b>MTO #:</b> <input type="text"/>
<b>Main Hwy / Road #:</b> <input type="text"/>	<b>Bridge Condition Index (BCI):</b> <input type="text" value="28"/>	<b>CRV:</b> <input type="text" value="\$57,200"/>
<b>Road Name:</b> <input type="text" value="Blue Trail"/>	<b>Inspection Date:</b> <input type="text" value="7/22/2021"/>	
<b>Structure Location:</b> <input type="text" value="95-North Line Extension"/>	<b>Next Inspection:</b> <input type="text" value="8/20/2023"/>	
<b>Condition Summary:</b> <input type="text" value="Repairs recommended"/> <b>Recommended Timing:</b> <input type="text" value="1-5 Years"/>	<b>Current Load Limit:</b> <input type="text" value="N/A"/>	
<b>Overall Comments:</b> <input type="text" value="Log beams supporting wood deck. Reinforcement recommended."/>

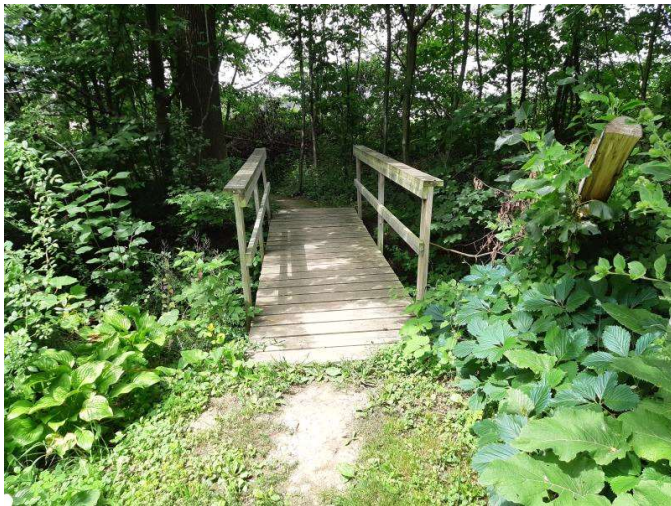
1-Facing West

<b>Structure Name:</b>	<input type="text"/>	<b>BMROSS File #:</b>	<input type="text"/>	<b>MTO #:</b>	<input type="text"/>
<b>Main Hwy / Road #:</b>	<input type="text"/>	<b>Bridge Condition Index (BCI):</b>	62	<b>CRV:</b>	\$36,400
<b>Road Name:</b>	Blue Trail	<b>Inspection Date:</b>	7/22/2021		
<b>Structure Location:</b>	West of Road 23		<b>Next Inspection:</b>	8/20/2023	
<b>Condition Summary:</b>	No work identified	<b>Recommended Timing:</b>	<input type="text"/>		
<b>Overall Comments:</b>	Wood beams supporting wood deck. Bridge is in fair condition.				
<b>Current Load Limit:</b>	N/A

Protection System:	None			BCI - Element Condition Values:		
Condition Data:	Excellent	Good	Fair	Poor	TEV	CEV
			100% (4.1)		\$615	\$246
Comments:	140 x 140 wood beams. Don't appear to rest on abutments.					
Performance Deficiencies:						
Recommended Work:						
					Recommended Timing:	None
Maintenance needs:						
Maintenance work:					Maintenance Priority:	
Element Data:						
Element Group:	Decks			Length:	4.91	
Element Name:	Deck Top - Thick Slab			Width:	1.5	
Location:				Height:	0.038	
Material:	Wood			Count:	1	
Element Type:	Wood Planks			Total Quantity:	7.4 m2	
Environment:	Benign			Limited / Not Inspected:	<input type="checkbox"/>	
Protection System:	None			BCI - Element Condition Values:		
Condition Data:	Excellent	Good	Fair	Poor	TEV	CEV
		100% (7.4)			\$2,590	\$1,943
Comments:						
Performance Deficiencies:						
Recommended Work:						
					Recommended Timing:	None
Maintenance needs:						
Maintenance work:					Maintenance Priority:

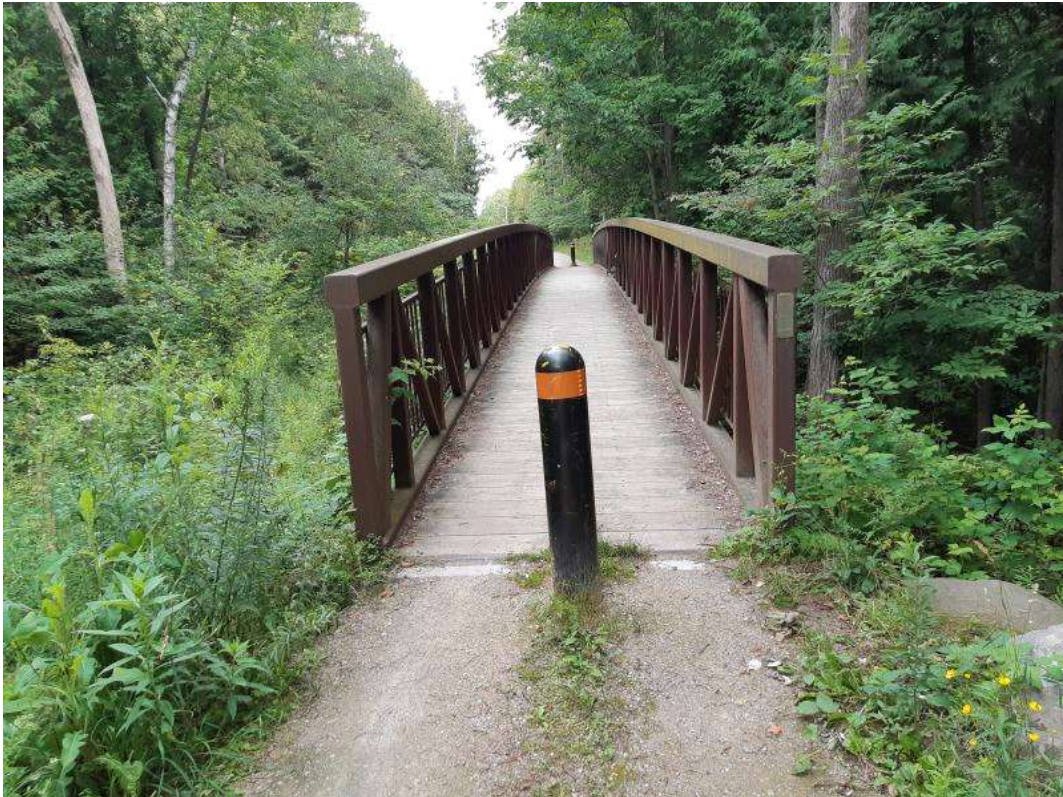
1-Facing North

Overall Structure Notes:	
<b>Bridge Condition Summary:</b> No work identified	<b>Recommended Timing:</b>
<b>Overall Comments:</b> Half-through truss in good condition.

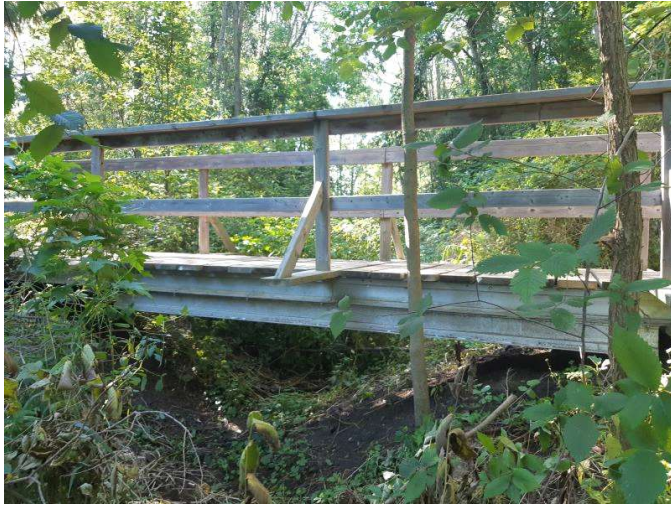
2-West Elevation

<b>Structure Name:</b> <input type="text"/>	<b>BMROSS File #:</b> <input type="text"/>	<b>MTO #:</b> <input type="text"/>	
<b>Main Hwy / Road #:</b> <input type="text"/>	<b>Bridge Condition Index (BCI):</b> <input type="text" value="66"/>	<b>CRV:</b> <input type="text" value="\$57,200"/>	
<b>Road Name:</b> <input type="text" value="Yellow Trail"/>		<b>Inspection Date:</b> <input type="text" value="7/21/2021"/>	
<b>Structure Location:</b> <input type="text" value="South of Bruce Ave."/>		<b>Next Inspection:</b> <input type="text" value="8/20/2023"/>	
<b>Condition Summary:</b> <input type="text" value="No work identified"/>	<b>Recommended Timing:</b> <input type="text"/>	<b>Current Load Limit:</b> <input type="text" value="N/A"/>	
<b>Overall Comments:</b> <input type="text" value="Aluminum beams supporting wood deck in fair to good condition."/>

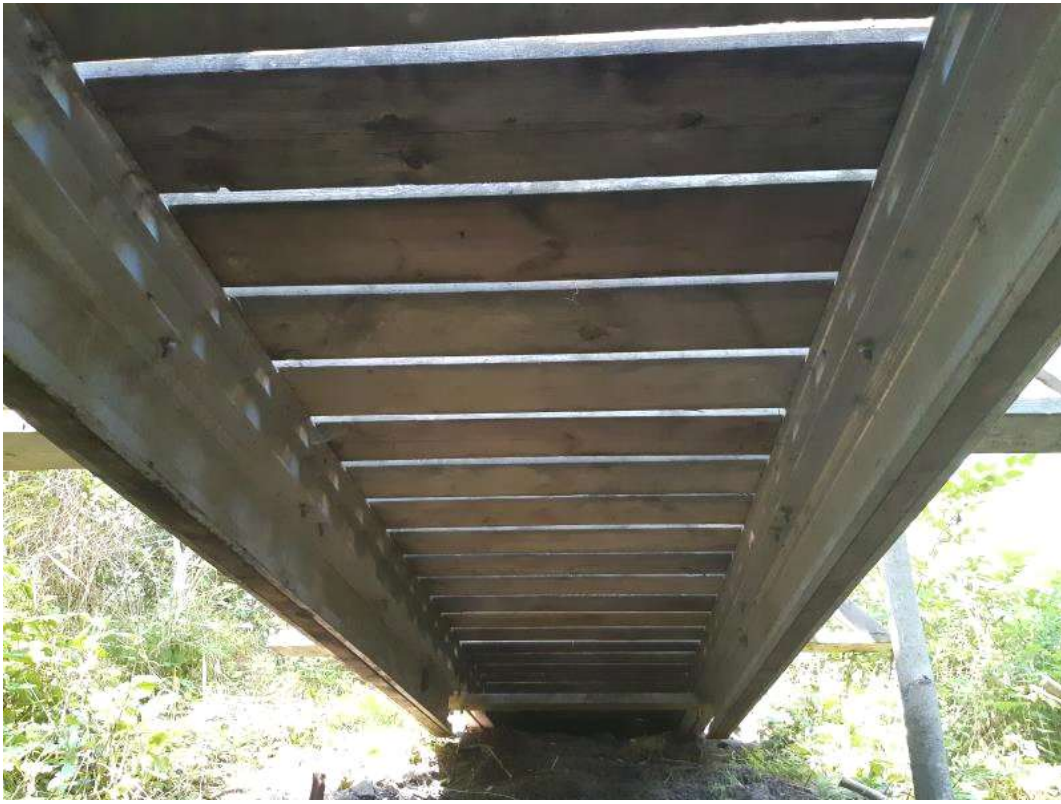
3-Soffit

Environment:	Benign			Limited / Not Inspected:	<input type="checkbox"/>	
Protection System:	None			BCI - Element Condition Values:		
Condition Data:	Excellent	Good	Fair	Poor	TEV	CEV
		100% (13.9)			\$2,780	\$2,085
Comments:	Beams taller at midspan. Beams rest on a bank at one end and lumber at the other end.					
Performance Deficiencies:						
Recommended Work:						
					Recommended Timing:	None
Maintenance needs:						
Maintenance work:						
					Maintenance Priority:	
Element Data:						
Element Group:	Decks			Length:	7.55	
Element Name:	Deck Top - Thin Slab			Width:	1.43	
Location:				Height:		
Material:	Wood			Count:	1	
Element Type:	Wood Planks			Total Quantity:	10.8 m2	
Environment:	Benign			Limited / Not Inspected:	<input type="checkbox"/>	
Protection System:	None			BCI - Element Condition Values:		
Condition Data:	Excellent	Good	Fair	Poor	TEV	CEV
		100% (10.8)			\$1,296	\$972
Comments:						
Performance Deficiencies:

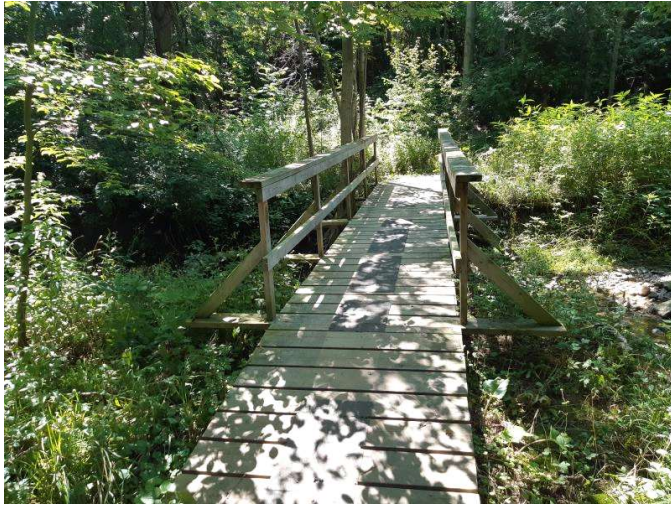
1-Facing West

Structure Name:	<input type="text"/>	BMROSS File #:	<input type="text"/>	MTO #:	<input type="text"/>
Main Hwy / Road #:	<input type="text"/>	Bridge Condition Index (BCI):	50	CRV:	\$88,400
Road Name:	Red Trail	Inspection Date:	7/21/2021		
Structure Location:	North End of Red Trail		Next Inspection:	8/20/2023	
Condition Summary:	No work identified	Recommended Timing:	<input type="text"/>		
Overall Comments:	Aluminum beam bridge supporting wood deck in fair condition.				
<input type="text"/>

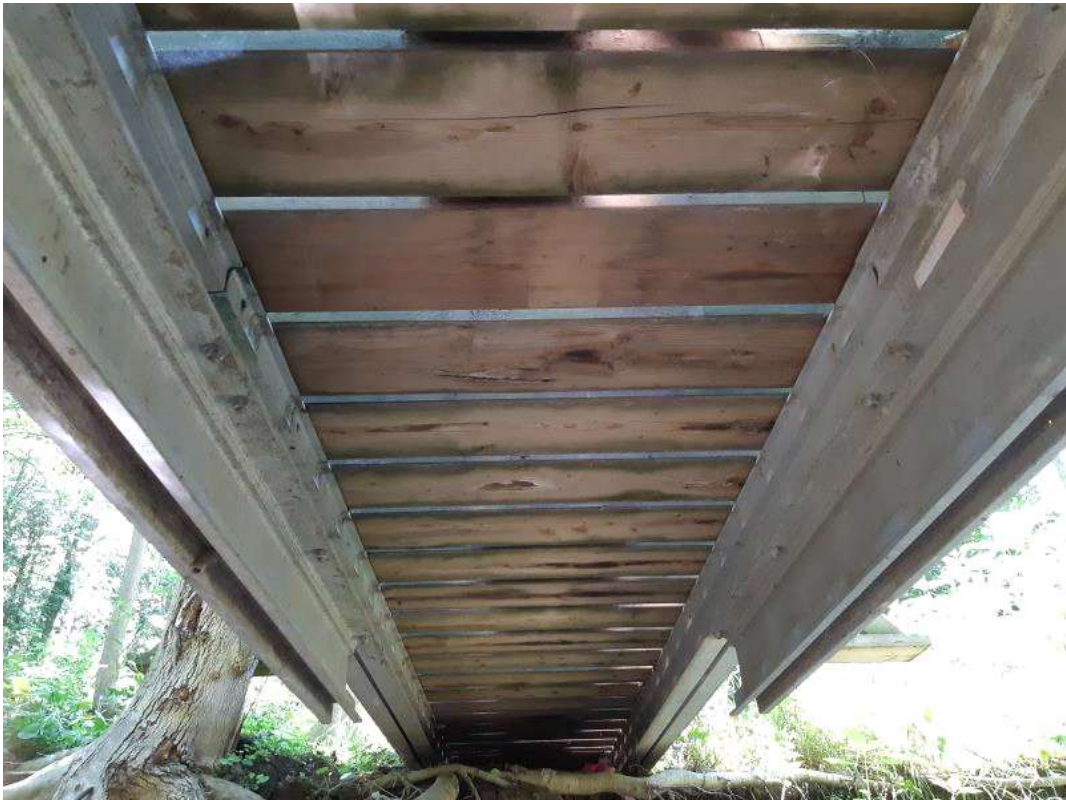
3-Soffit

Protection System:	None			BCI - Element Condition Values:		
Condition Data:	Excellent	Good	Fair	Poor	TEV	CEV
			100% (13)		\$2,600	\$1,040
Comments:	Beams taller at midspan. Rest on 140 x 140 lumber and banks. Noticeable deflection when walking on deck.					
Performance Deficiencies:						
Recommended Work:						
					Recommended Timing:	None
Maintenance needs:						
Maintenance work:						
					Maintenance Priority:	
Element Data:						
Element Group:	Decks			Length:	11.9	
Element Name:	Deck Top - Thin Slab			Width:	1.43	
Location:				Height:		
Material:	Wood			Count:	1	
Element Type:	Wood Planks			Total Quantity:	17 m2	
Environment:	Benign			Limited / Not Inspected:	<input type="checkbox"/>	
Protection System:	None			BCI - Element Condition Values:		
Condition Data:	Excellent	Good	Fair	Poor	TEV	CEV
		100% (17)			\$2,040	\$1,530
Comments:						
Performance Deficiencies:						
Recommended Work:						
					Recommended Timing:	None
