MUNICIPALITY OF KINCARDINE

BRIDGE INSPECTION REPORT

MUNICIPALITY OF KINCARDINE
BRIDGE INSPECTION REPORT
2021

October 22, 2021

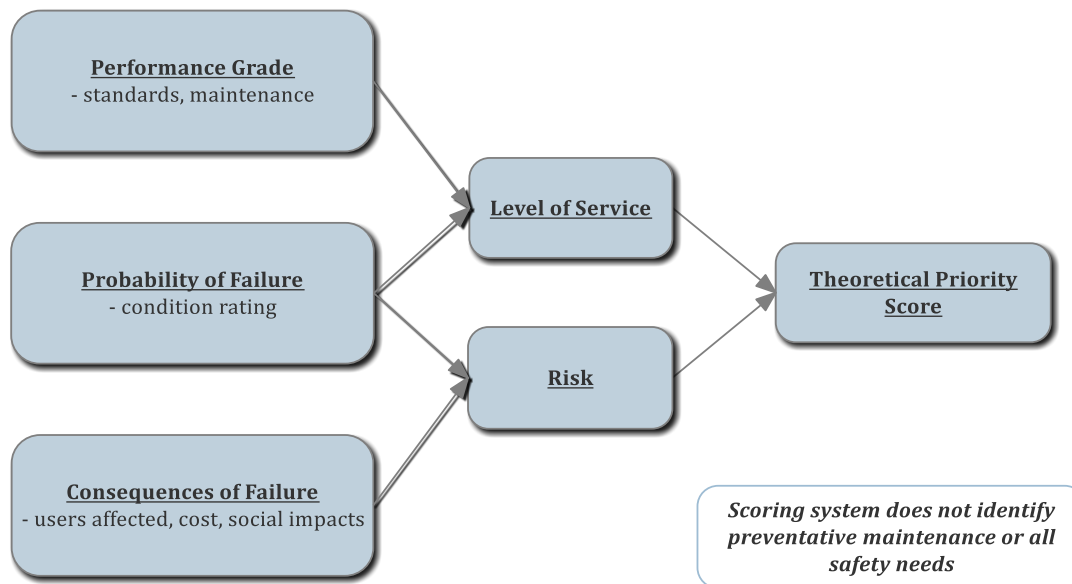
Figure 1
Relationship between Data Collected and Calculated Theoretical Priority Scores

score based on the number of users affected if the asset cannot be used safely or other social impacts and the cost of the asset. The **performance grade** should incorporate the relative maintenance requirements of the asset and a comparison of how the asset was built versus the appropriate design standard for that particular asset. In a simplified way these components were used as illustrated in Figure 1 to develop a theoretical priority score for the improvements.

BMROSS has developed a scoring system to help prioritize the improvement needs as per the relationship shown in Figure 1 and as a starting point have implemented a suggested scoring and weighing system. For this study, the width of the bridge or culvert and the presence or lack of a load limit was used to calculate a performance grade for each road section. If the Municipality desires, in the future, other characteristics could be used to further refine this scoring system. If the width of the structure was, in our opinion, appropriate for a two-lane road a score of 1 was applied. If the width was somewhat narrow to accommodate two lanes of traffic, a score of 3 was applied and if the bridge was only suitable for a single lane of traffic, a score of 5 was applied. Similarly, the good score of 1 was assigned if the structure does not have a load limit and a score of 5 was assigned if there is a current or pending load limit. The average of the structure width and load limit score was used in the evaluation.

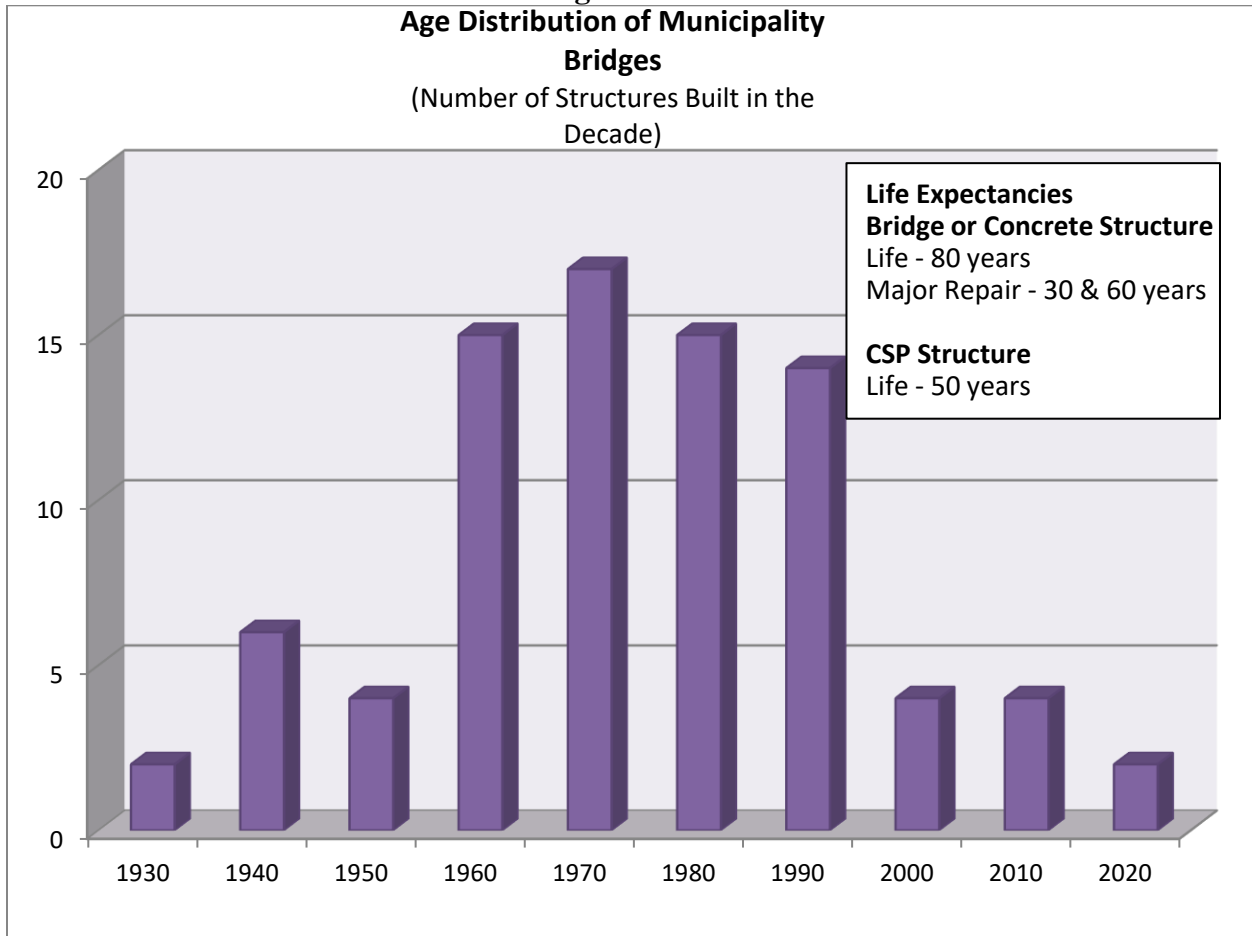
Figure No. 2
Age Distribution of Municipality
Bridges
 (Number of Structures Built in the
 Decade)

The Ontario Ministry of Transportation's *Structural Financial Manual* from 1993 suggests that the average service life of a bridge in Ontario is about 50 years. Other references and the new Bridge Code suggest bridges should provide a service life of 75 years. It is our opinion that rural bridges in this part of Ontario can be expected to provide a service life of about 80 years if properly maintained and repaired. Eighty-three structures were reviewed (81 bridges and 2 small span structures). On average, the Municipality should be replacing five structures in any 5-year period to avoid a concentrated replacement program in the future. Five structures were identified as requiring replacement in the next 5 years, and seven structures were identified as requiring replacement in the 6 to 10-year period. Figure No. 2 shows an age distribution of the structures in the Municipality based on documented and estimated dates of construction.
